ARTICLE 8
June 21, 2017

Looking into Gas Tank Linings

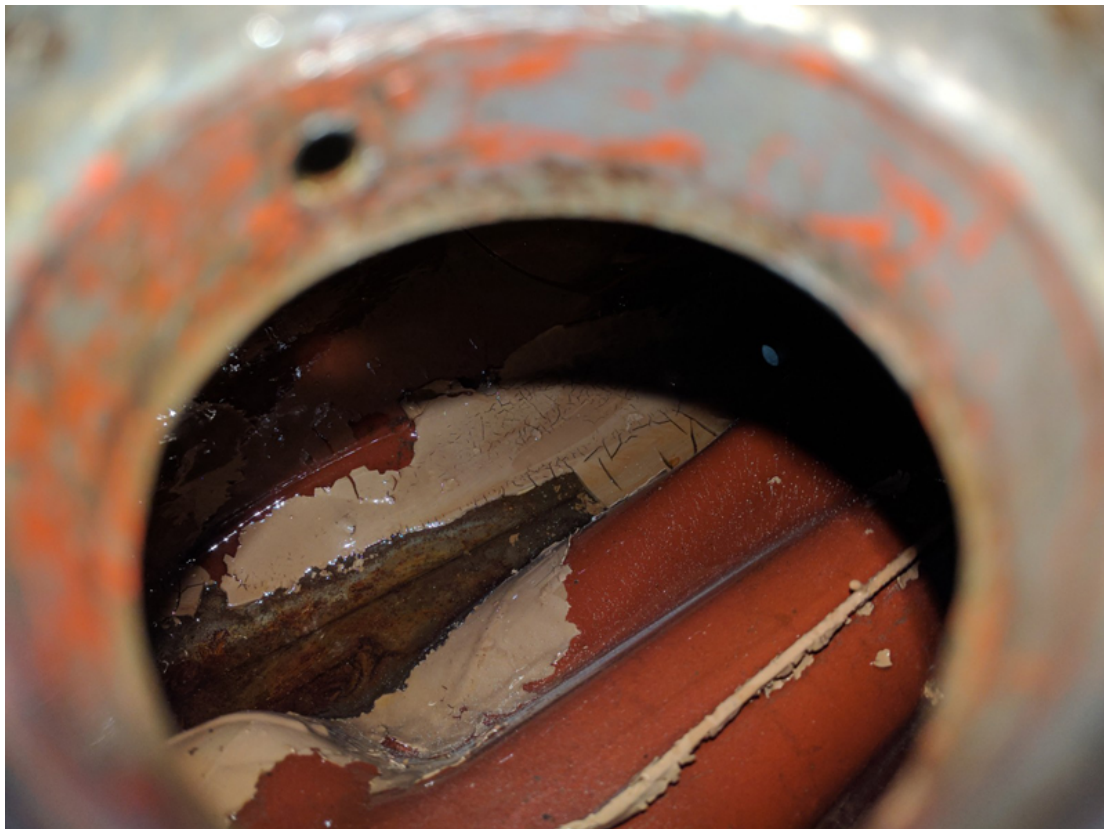
Have you ever peered inside the gas tank of your older BMW motorcycle? If not, take the opportunity to shine a flashlight through the filler neck and look into the recesses of the tank. In most cases, you'll see a reddish coating that covers the interior of the tank. It should be even in appearance and intact wherever you are able to see. There shouldn't be any evidence of the coating flaking or peeling or bubbling. Any areas that are missing the coating will lead to the buildup of rust and debris in the tank and your fuel system from the deteriorating lining. This is often evident on the bottom of the tank, but clogged fuel filters are the 1st warning sign of a failed tank lining. Finer rust and lining particles can even make their way past the filters and into your carburetors leading to continual tuning and running issues.

The original tank linings were never meant to withstand the ethanol levels found in current gasolines, and will peel away fairly quickly leaving uncoated areas subject to rust and corrosion. Especially in bikes that sit for extended periods with untreated gasoline in the tanks.

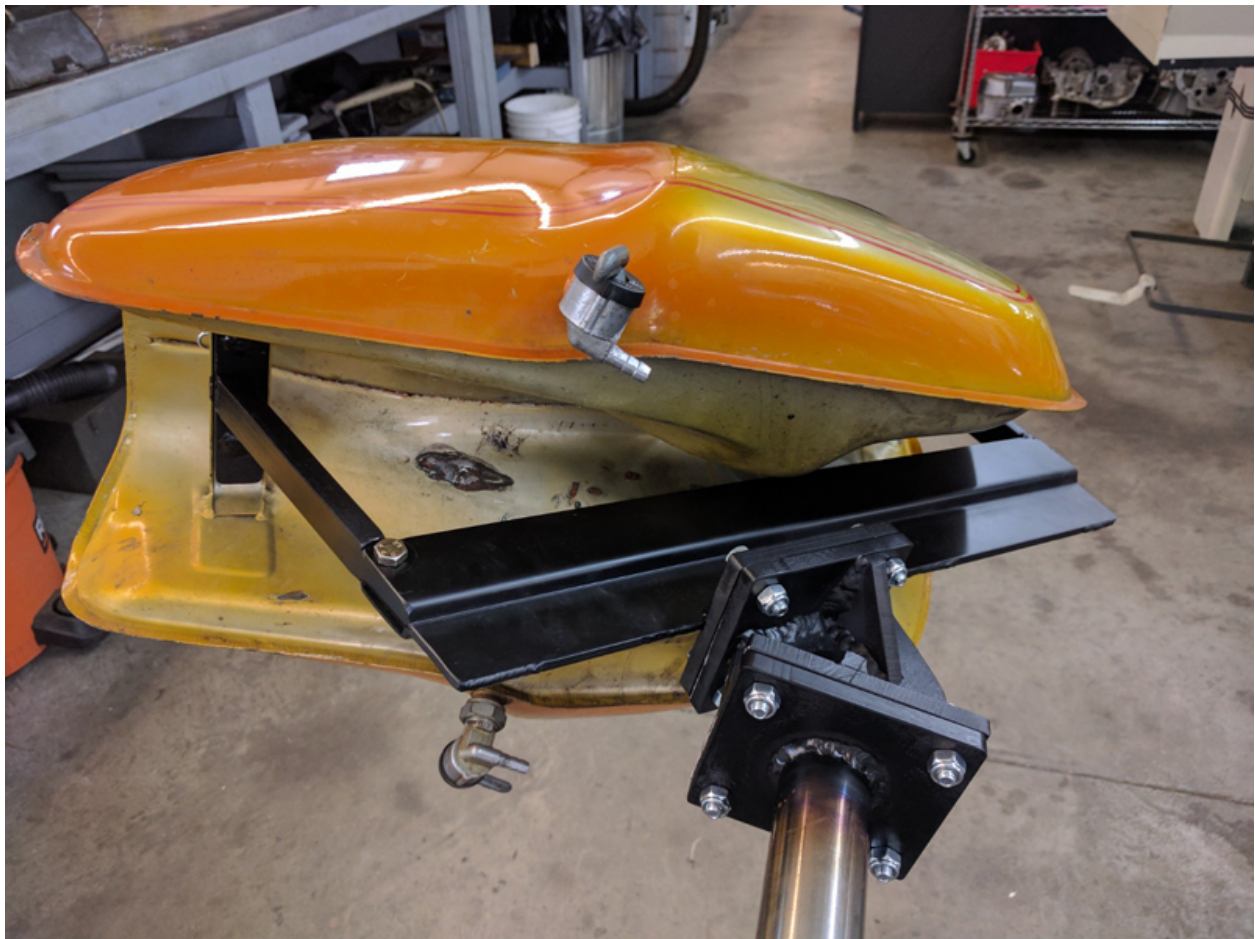
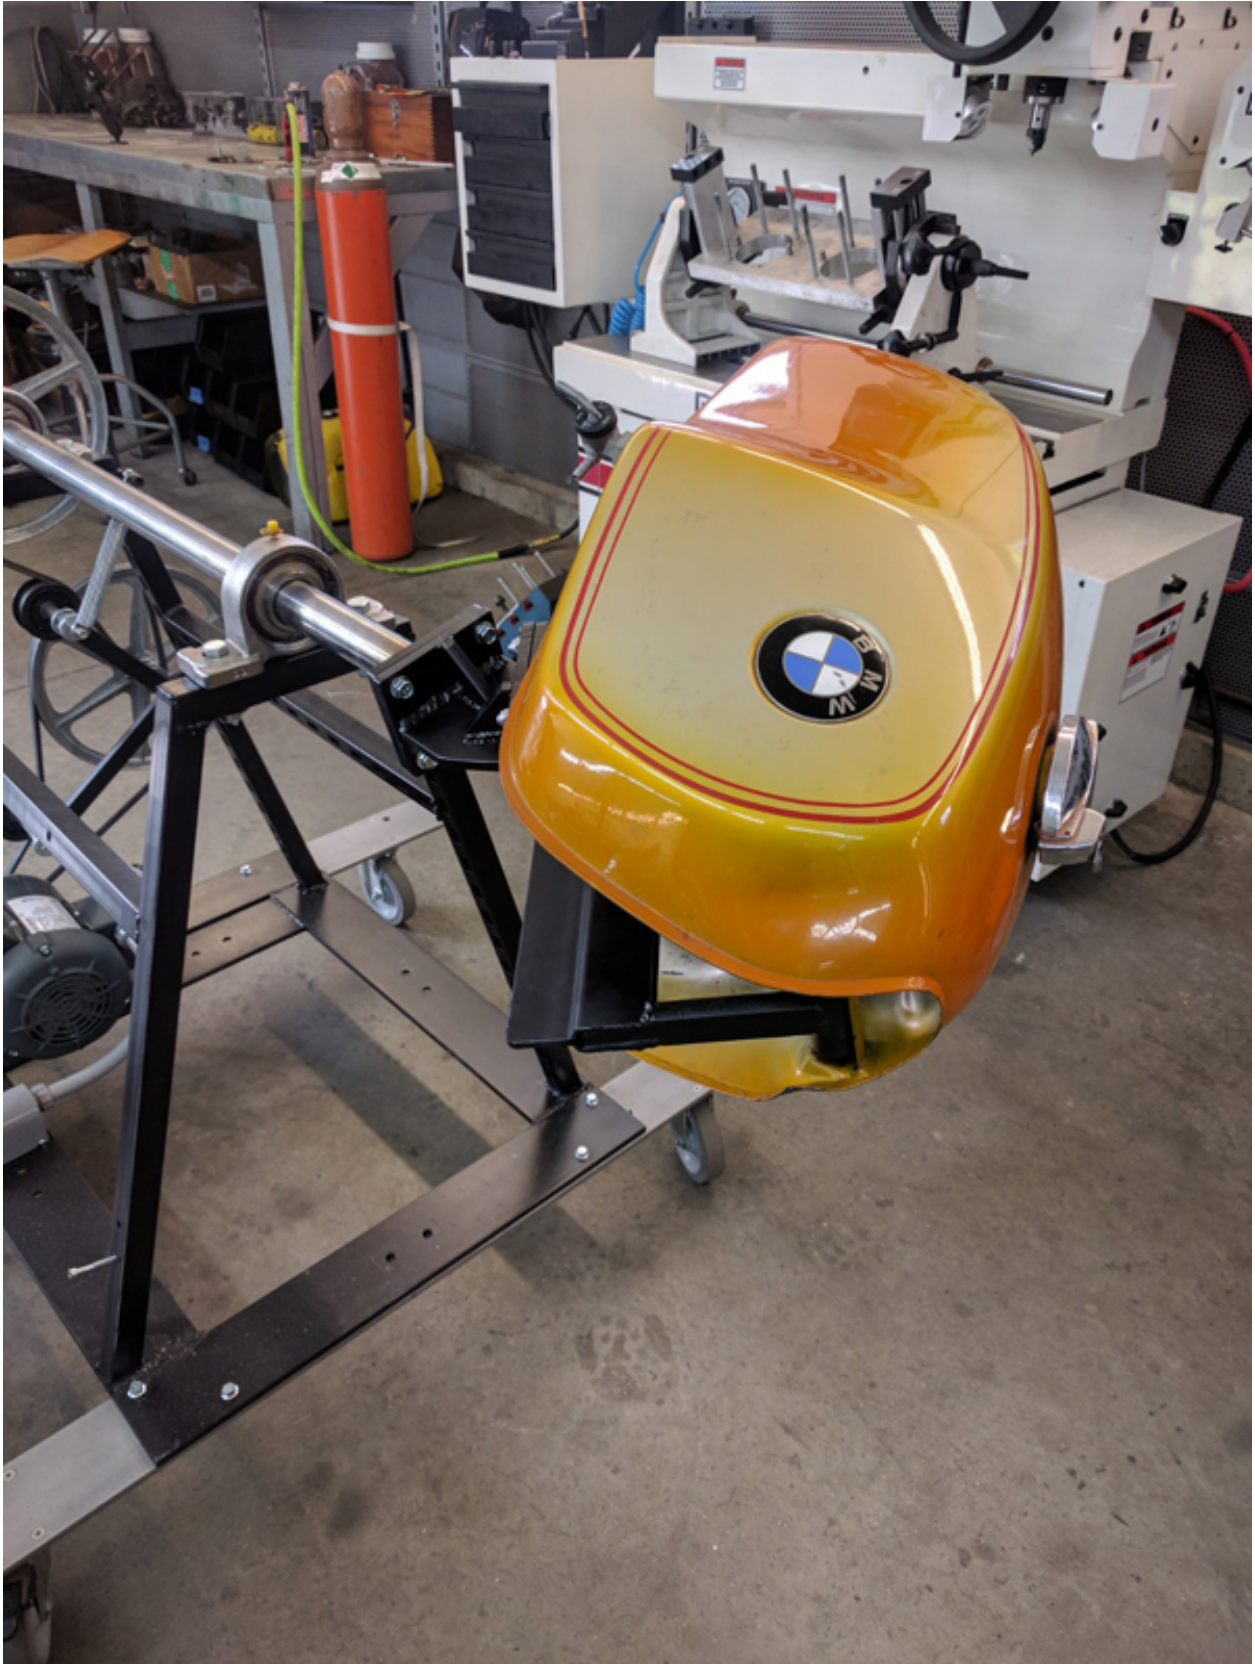
Our Machine Shop has a very effective process to completely and safely strip out your old, compromised lining, remove rust and clean out your tank. We mount your tank securely to our tumbler just as it mounts on your motorcycle. This ensures your exterior paint is untouched and safe during tumbling. The tank is filled with abrasive media in a rust inhibiting solution and obliquely rotated in both forward and reverse directions until thoroughly cleansed of old lining material and rust. Our borescope confirms success in difficult to see areas and behind baffles.

Once the inside of the tank is perfectly bare, we treat the interior and coat it with a double dose of a modern lining product that is impervious to ethanol and other additives in today's gasolines. This is a time proven formula that will provide worry free operation of your classic BMW motorcycle.
